Kilgore, TX	TYPE: Software Upgrade Procedure	NO: FCT-1367-32	REV: B
	TITLE: R8000 Upgrade 1.11.1.0 to 1.11.2.0	PAGE: 1 OF 5

Purpose

This procedure upgrades the communications system analyzer software to 1.11.2.0. The update may be applied only to systems with the following system version:

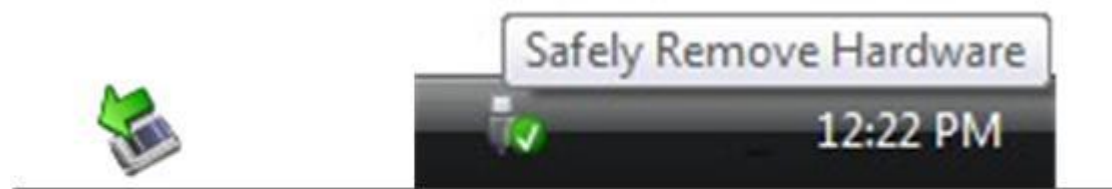
3. Use the "Safely Remove Hardware" icon in the system tray area (bottom right corner of the screen on most Windows installations) of the task bar.

Windows XP

Windows Vista / 7
