Kilgore, TX	TYPE: Software Upgrade Procedure	NO: FCT-1367-39	REV: C
	TITLE: R8000 Upgrade 1.16.0.0 to 1.17.0.0	PAGE: 1 OF 6

Purpose

This procedure upgrades the communications system analyzer software to 1.17.0.0. The update may be applied only to systems with the following system version:

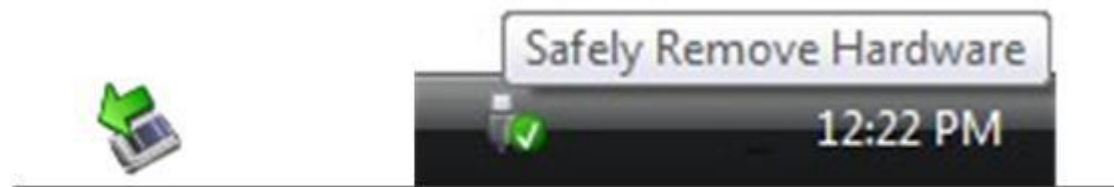
3. Use the "Safely Remove Hardware" icon in the system tray area (bottom right corner of the screen on most Windows installations) of the task bar.

Windows XP

Windows Vista / 7
