Kilgore, TX	TYPE: Software Upgrade Procedure	NO: FCT-1367-42	REV: B
	TITLE: R8000 Upgrade 1.18.0.0 to 1.19.0.0	PAGE: 1 OF 6

This procedure upgrades the communications system analyzer software to 1.19.0.0. The update may be applied only to systems with the following system version:

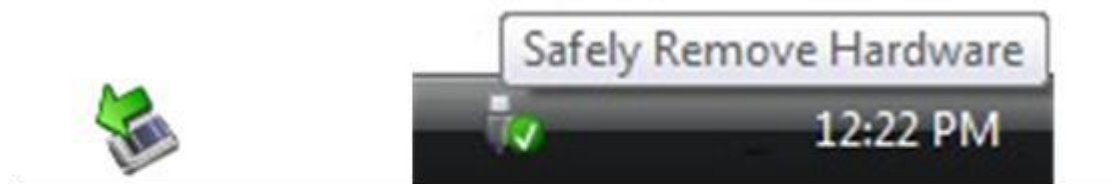
3. Use the "Safely Remove Hardware" icon in the system tray area (bottom right corner of the screen on most Windows installations) of the task bar.

Windows XP

Windows Vista / 7
