Kilgore, TX	TYPE: Software Upgrade Procedure	NO: FCT-1367-19	REV: B
	TITLE: R8000 Upgrade 1.7.1.0 to 1.7.1.1	PAGE: 1 OF 6

Purpose

This procedure upgrades the communications system analyzer software to 1.7.1.1. The update may be applied only to systems with the following system version:

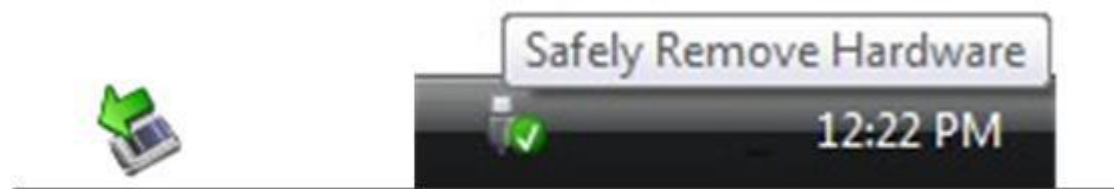
3. Use the "Safely Remove Hardware" icon in the system tray area (bottom right corner of the screen on most Windows installations) of the task bar.

Windows XP

Windows Vista / 7
